FILe Approved For Release 2003/03/04 : CIA-RDP78T05161A000900010042-4 25X **MAGERY** MALYSIS PHOTOGRAPHIC INTELLIGENCE REPORT NEW SHIPYARD UNDER KUANG-CHOU, CHINA 25X1

CIA/PIR 67235

KUANG-CHOU, CHINA

NEW SHIPYARD UNDER CONSTRUCTION

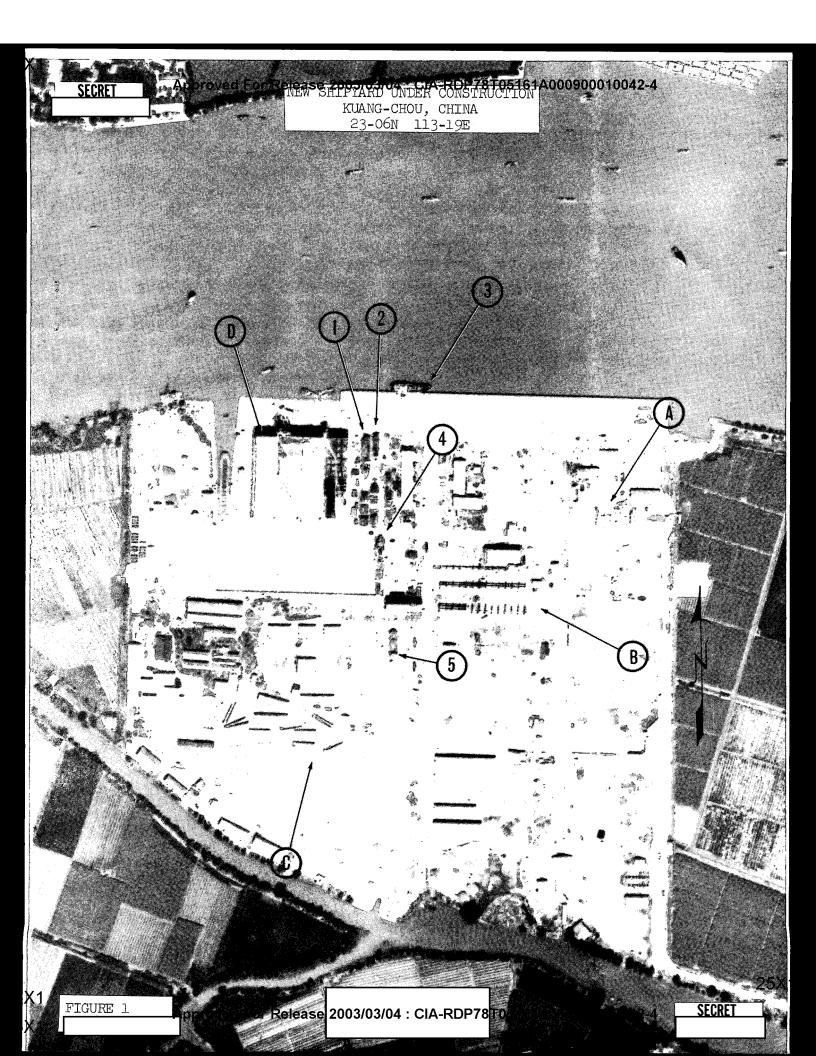
Approved For Release 2003/03/14/14/14-RDP78T05161A000900010042-4		
		CIA/PIR-67235	25X ²	
		CIA IMAGERY ANALYSIS DIVISION		
	LOC	PYARD: NEW SHIPYARD UNDER CONSTRUCTION CATION: KUANG-CHOU, CHINA COORDS: 23-06N 113-19E	25X1	
25X1		KEY TO VESSEL ANNOTATIONS

1.	Unidentified vessel under construction (LOA approx 130'). See annotation 4,		
25X1	2.	Unidentified vessel under construction (LOA approx 80').		
25X1	3.	Unidentified vessel at fitting-out quay (LOA approx 130'). See annota tion 3,	-	
25X1	4.	Unidentified vessel on transverser (LOA approx 130'). See annotation 2,		
25X1	5•	Unidentified barge under construction (LOA approx 90'). See annotatio	n 1,	
		KEY TO FACILITY ANNOTATIONS	25X1	
25X1	Α.	Unidentified building under construction. No progress in construction is noticeable since annotation annotation		
	В.	Possible fabrication building. Structural steel erected since indicates that the northern bay of the building may be about one story high, the other approximate two stories tall. See annotation D,	25X1 ^{Ly} 25X1,	
25X1	С.	Probable prefabricated roof trusses. These eleven trusses appear to be undisturbed since annotation B, See	25X1	
25X1	D.	Construction hall. The three westernmost construction bays appear structurally complete. Trusses do not appear to in place for the entire length of the bay. See annotation G,	2J/ I
